### **Local Planning Panel**

**Thursday, 06 June 2024**

## GEORGES RIVER LOCAL PLANNING PANEL MEETING

#### **LPP018-24      1174 Forest Road Lugarno**

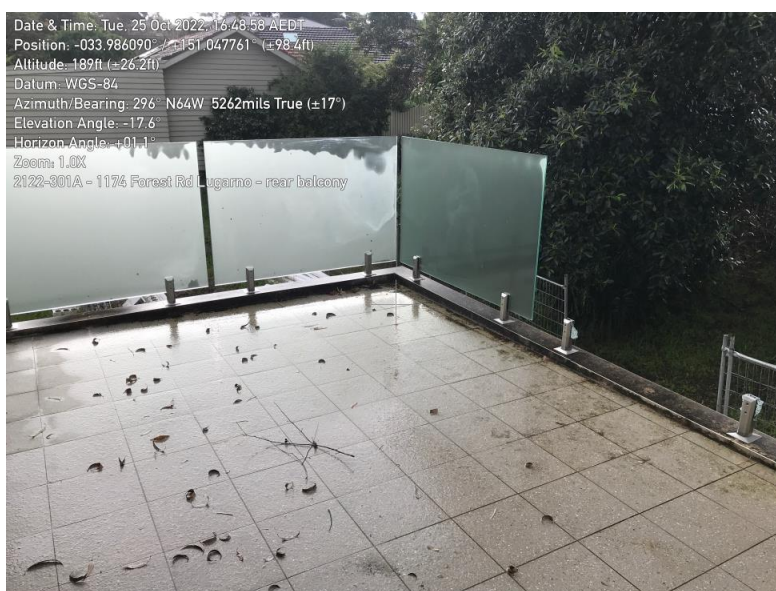
Image 3 & Image 4 – BCA compliance

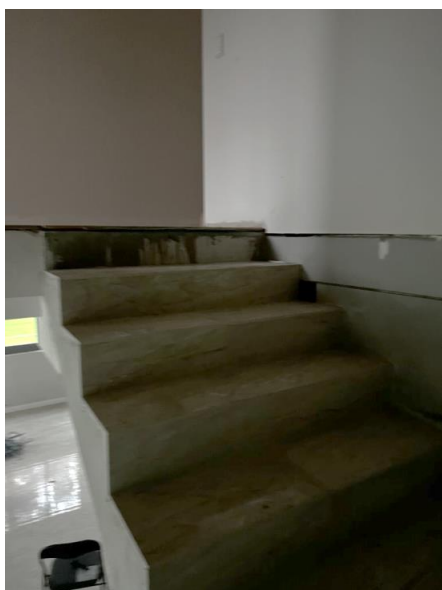
Image 5 – Missing balustrade pane to be installed.

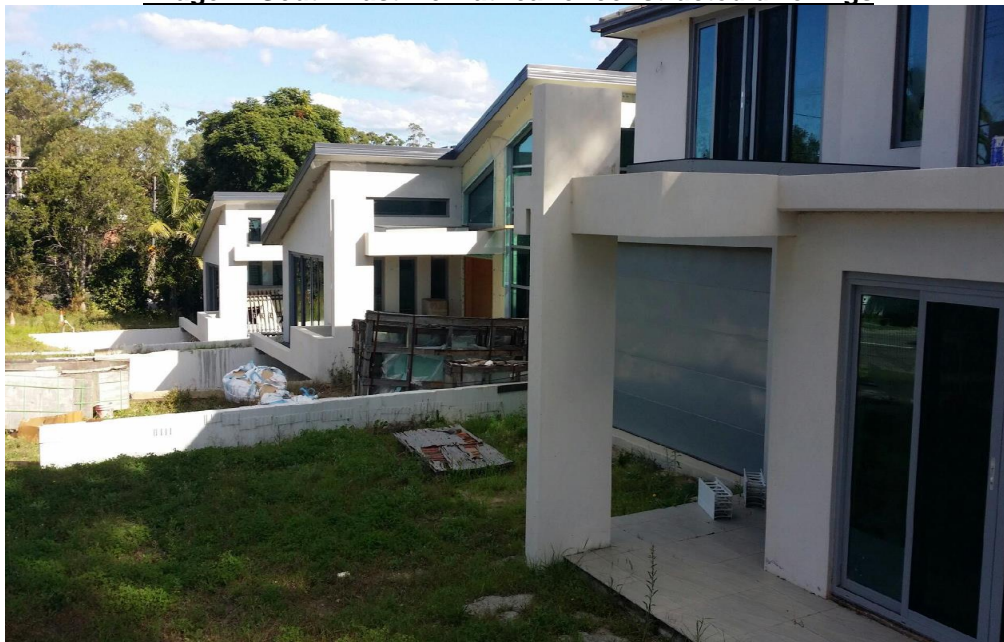
**Image 1: South-East view at rear of constructed dwellings**

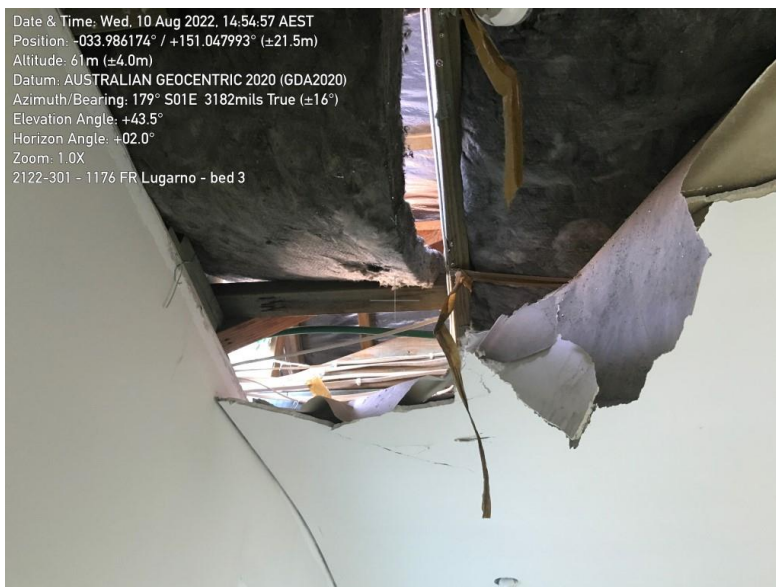
Image 6 – Bedroom 3 ceiling damage.

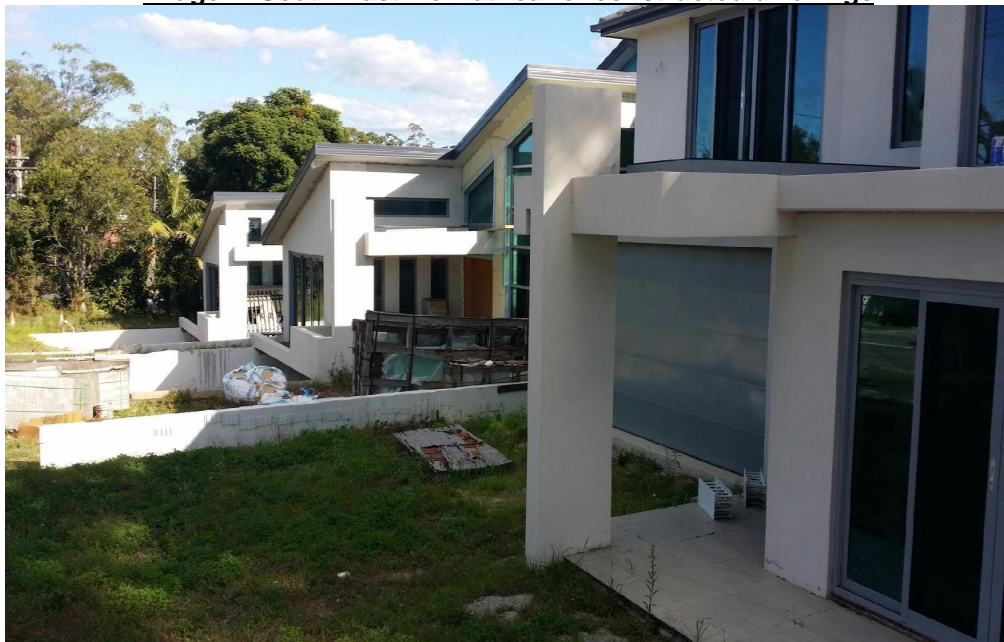
**Image 1: South-East view at rear of constructed dwellings**

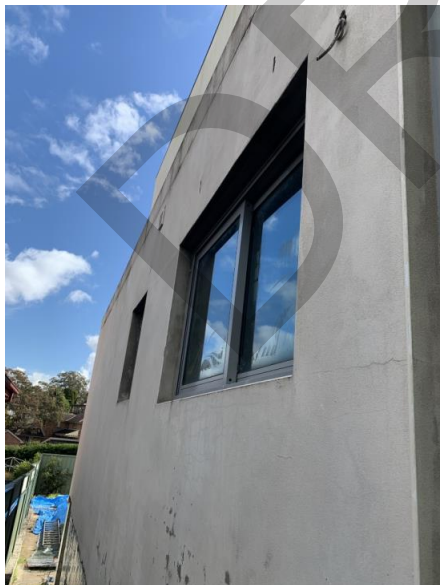
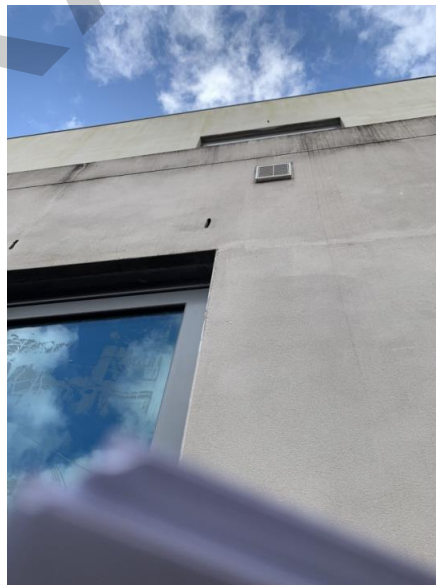
Image 5 – West elevation existing condition.

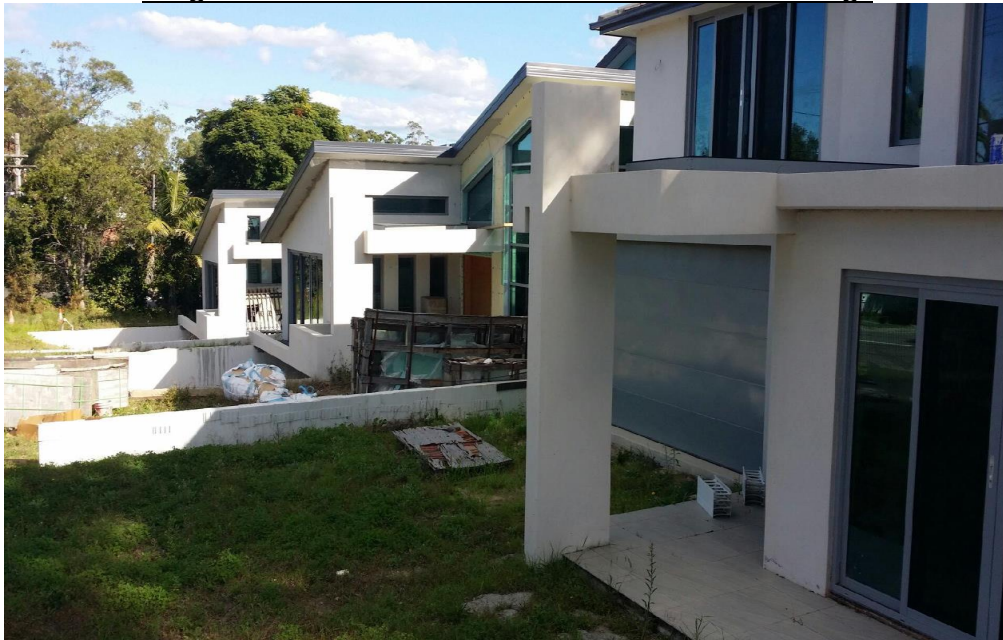
**Image 1: South-East view at rear of constructed dwellings**

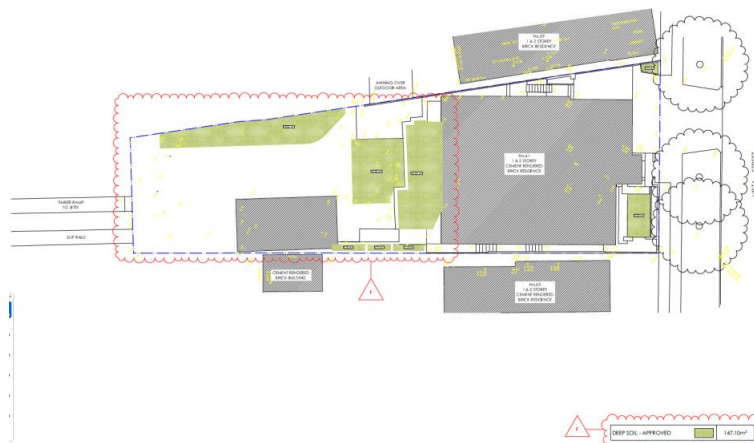
Figure 13 Deep Soil – Approved

- **Deep Soil – Approved** (Drawing S4.55 -09): This plan shows the “approved” landscaped area under DA2021/0081. This includes the relevant design change conditions outlined in Condition 9 of the consent which required impervious area to become grass areas. The DA was approved with total landscaped area of 147.10m<sup>2</sup> (16.2% of the site area). The approved site area under the original DA also fails to achieve the minimum 25% site area required under Clause 6.12 of the GRLEP 2021.
